Geneva Community Unit School District #304
Operations and Maintenance
5 and 7 Year Capital Improvement Plans

Board of Education Meeting
April 14, 2014

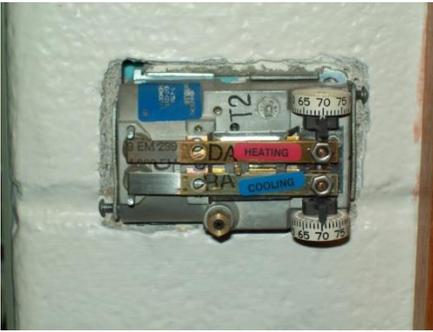
Controls

Pneumatic to Digital conversion allowing for tighter control of temperature, setback features, alarming feature and will be computer based.

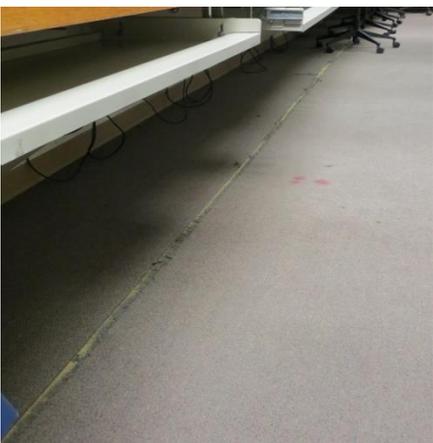
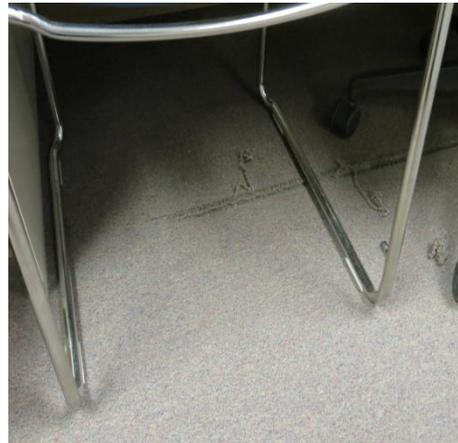
The carpet is starting to fray and cause trip hazards.

Carpet will need to be replaced.

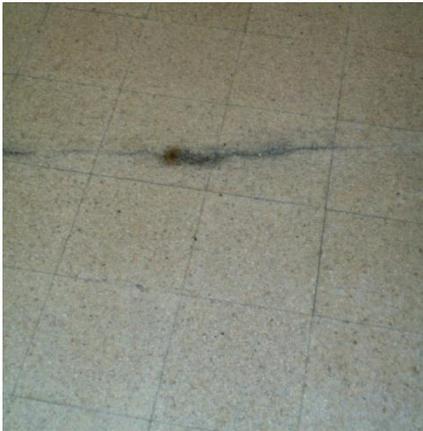
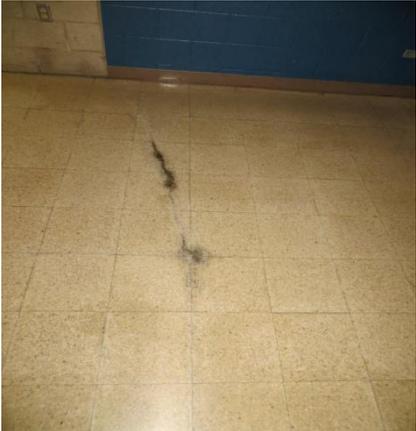
Flooring

Existing quartz tile is cracking and has faded.

Replace tile in phases.

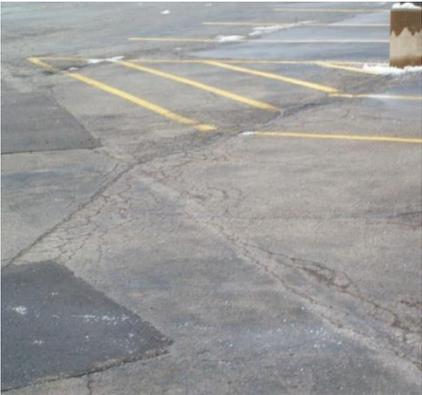
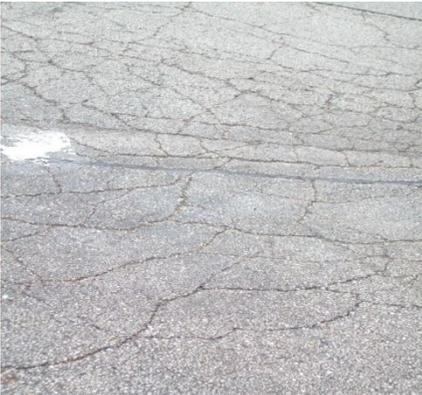
Center Street Parking Lot

Cracks and patches throughout lot.

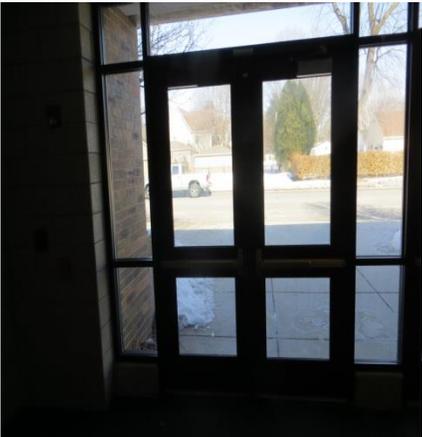
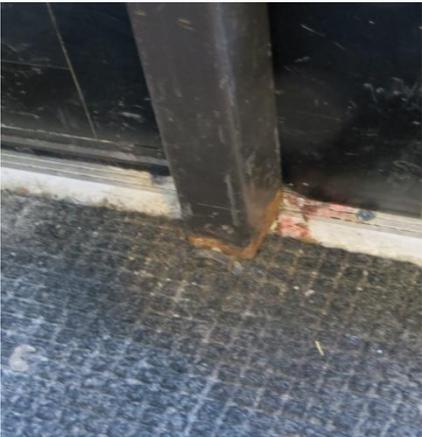
Center Street Doors

Frames starting to rust through.

Replace with heavy duty exterior doors.

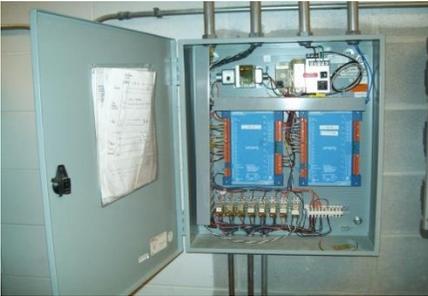
Lon Controller

Lon controls throughout the building.

Outdated and costly to repair.

Replace Lon to Bacnet.

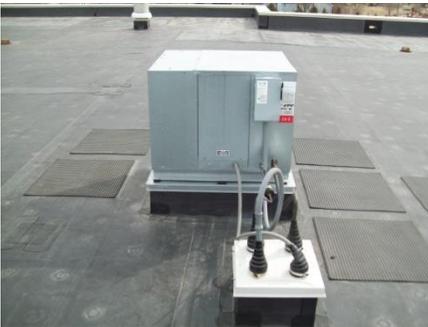
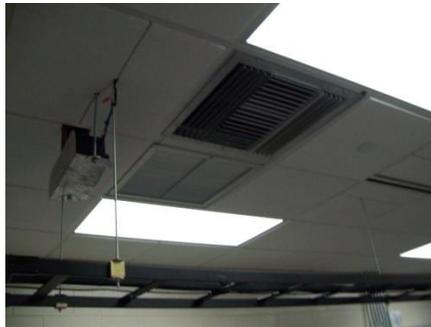
IT Server A/C

Oversized for heat load of space.

Cycles on and off continually causing condensation issues and premature equipment failure.

Replace with properly sized unit.

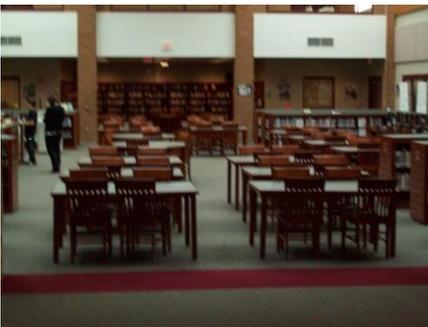
LMC

AHU is undersized for space.

Only 2 VAV boxes serving the space.

Recommend increasing the capacity of the AHU and adding 4-6 VAV boxes with controls to increase comfort and control humidity.

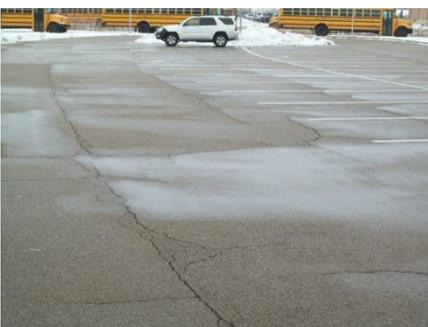
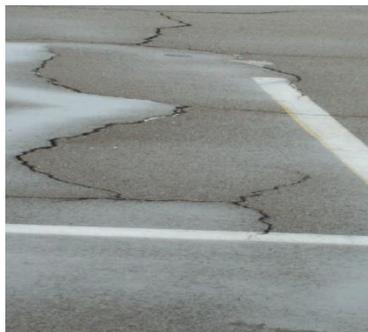
Parking Lot

Multiple deep cracks.

Crack filling and seal coating will extend the life of the parking lot.

Resurfacing may be required within the next five to seven years.

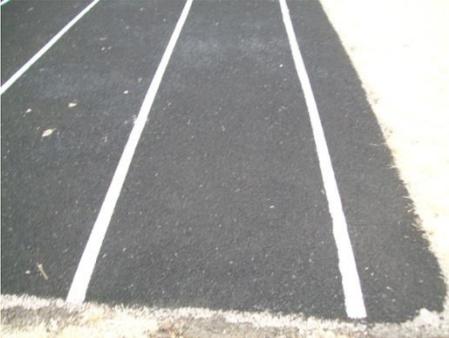
Track – installed in 2005

Track resurfacing is normally required every 8-10 years.

Excessive wear spots are apparent.

Resurfacing will be needed this year.

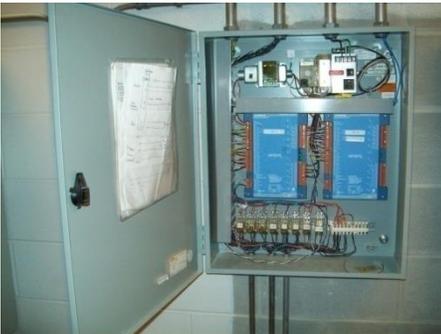
Lon Controller

Lon controls throughout the building.

Outdated and costly to repair.

Replace Lon to Bacnet.

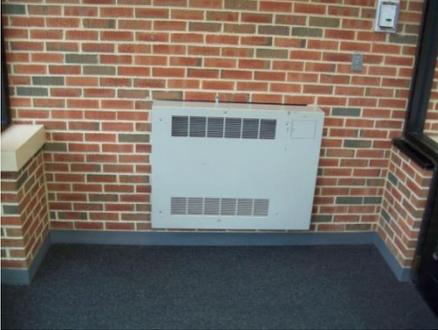
Cabinet Unit Heaters

15 units are over 35 years old.

Replace with energy efficient units.

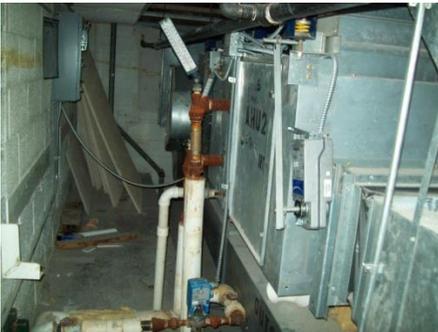
Air Handling Unit

Needs rebuilding or possible replacement.

New motor, shaft, bearings and controls needed.

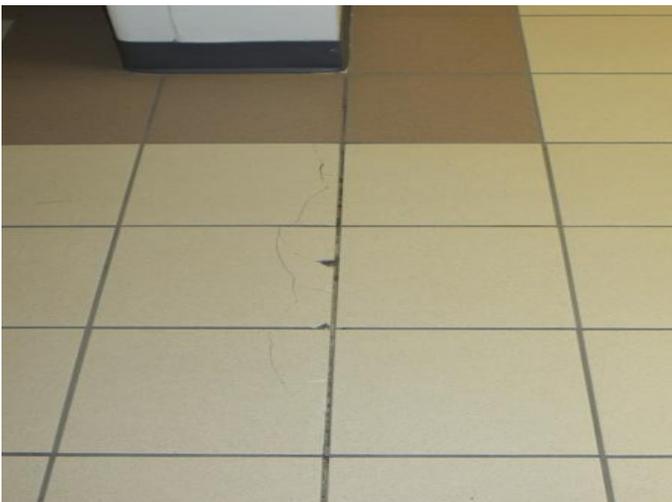
Floor Tile

Damaged floor tile that will need to be replaced with expansion joints.

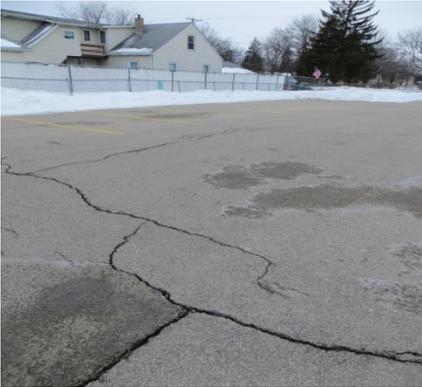
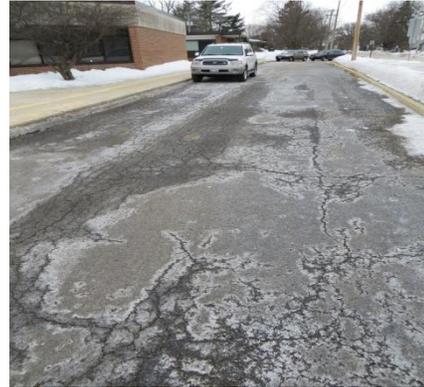
Parking Lot

Multiple deep cracks.

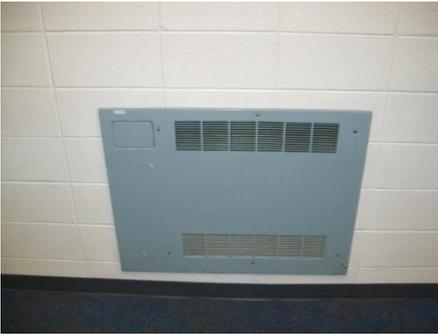
Cabinet Unit Heaters

9 units are over 20 years old.

Replace with energy efficient units.

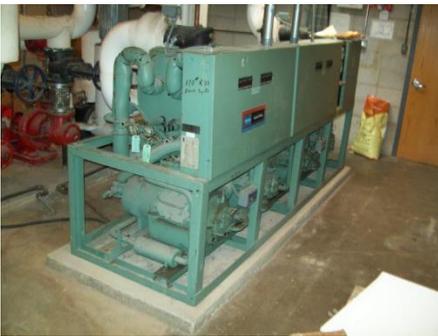
25 year old Chiller is inefficient and repairs are becoming more frequent.

Replace with new chiller.

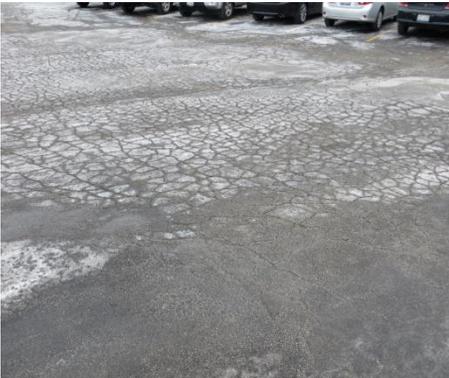
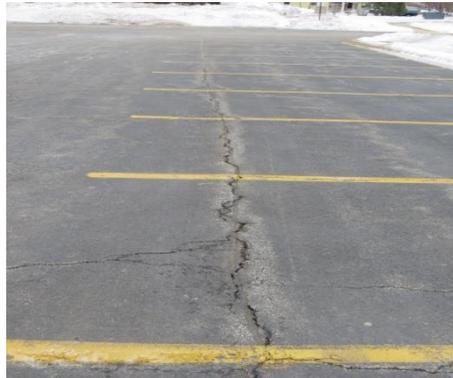
Parking Lot

Multiple deep cracks.

Resurfacing will be required.

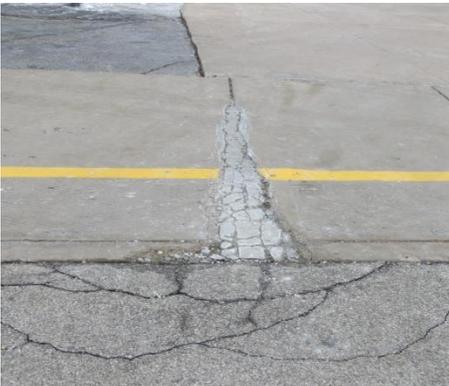
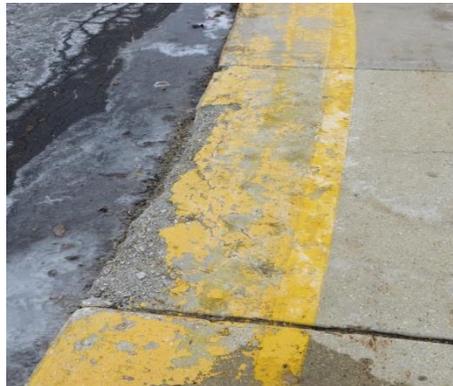
Sidewalks

Cracked and spalling sidewalk sections will need to be replaced.

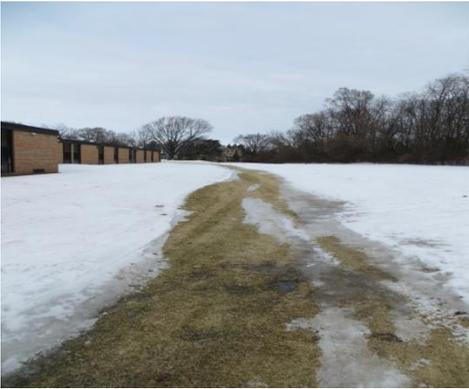
No access on East side of building.

Adding a paved Fire Lane for snow removal and First Responders.

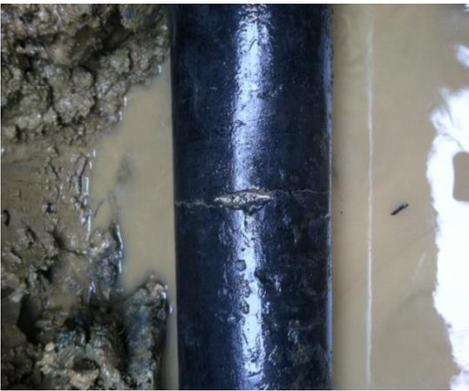
Water Main Replacement

Replace water main section that has cracked three times over the past five years.

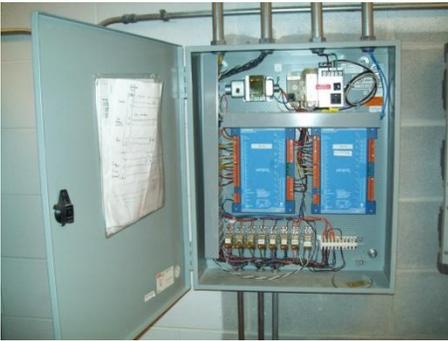
Lon Controller

Lon controls throughout the building.

Outdated and costly to repair.

Replace Lon to Bacnet.

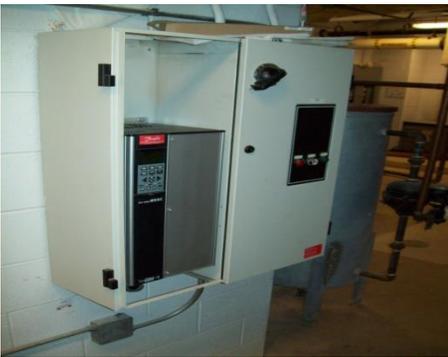
Variable Frequency Drive (VFD)

VFDs have started failing this year.

All units need replacing.

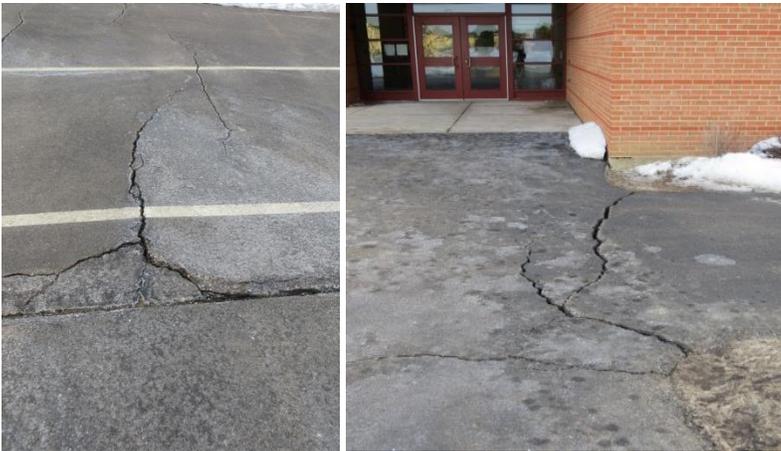
Fire Lane

Multiple deep cracks.

Seal coating and crack filling was done two years ago to extend life of the playground and 5th grade wing entrance.

Resurfacing or replacing damaged sections will be required this year.

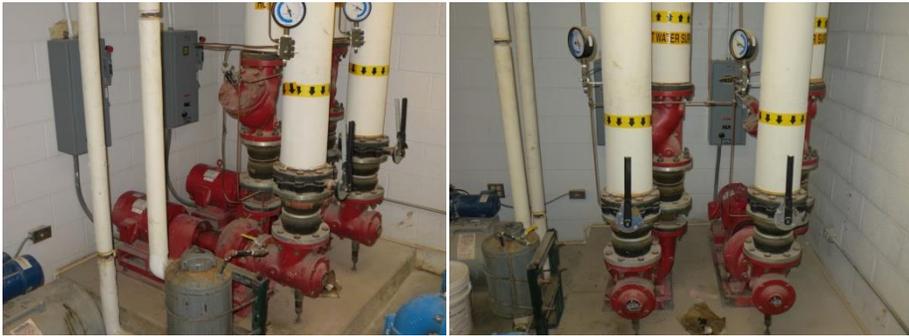
Primary and Secondary Boiler Pumps

Original to the building.

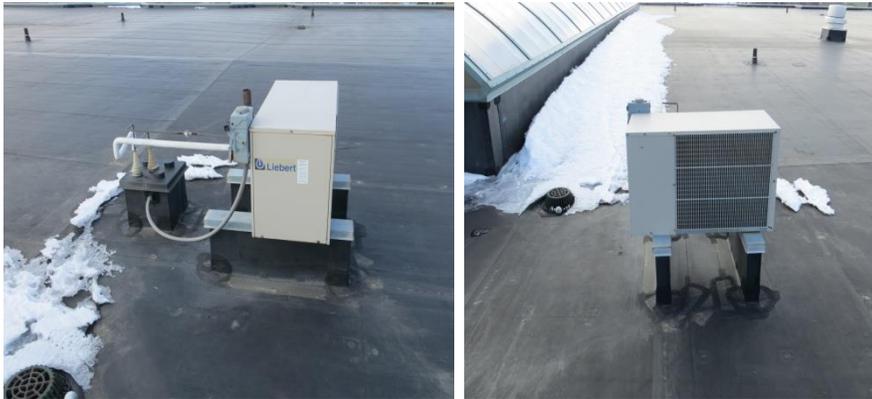
Air Handling Unit

Air handling units are nearing the end of their life cycle.

Will need to be replaced in the next five to seven years.

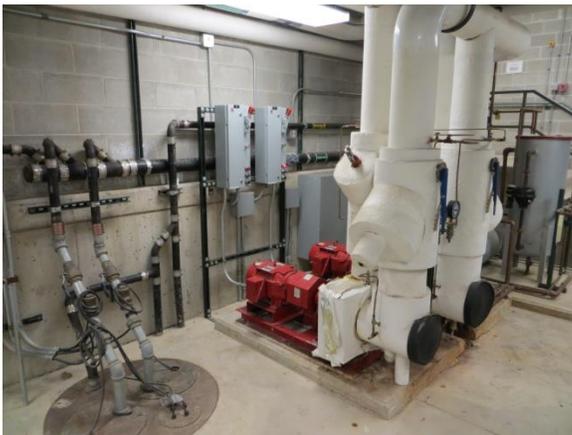
Chilled Water Pumps (2) – Add VFD

Variable Frequency Drives will greatly increase energy efficiency and lengthen the life of the pumps.

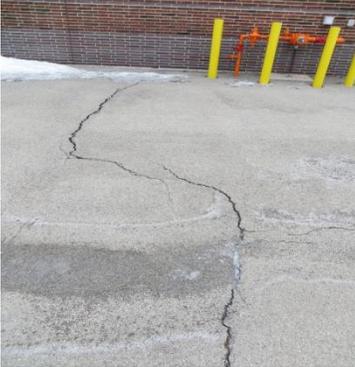
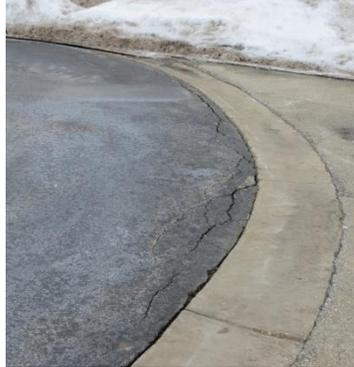
Parking Lot

Several areas are showing cracks and heaving.

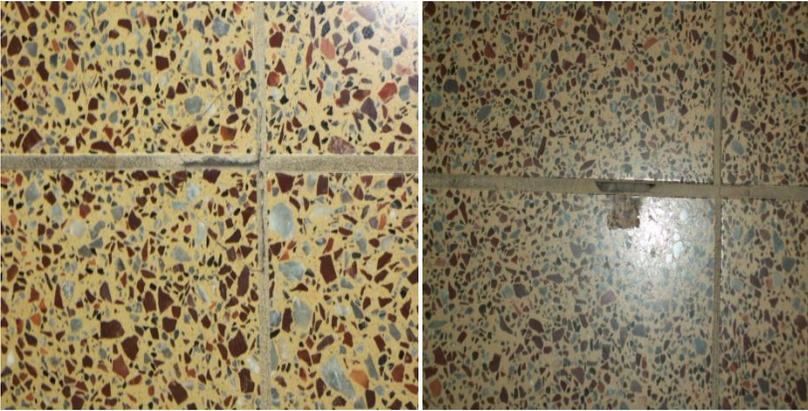
Floor Tile

Terrazzo tile repair/replacement.

Tile did not properly bond to the floor and is cracking.

Carpet will replace tile in upstairs' classroom wings Spring Break 2014

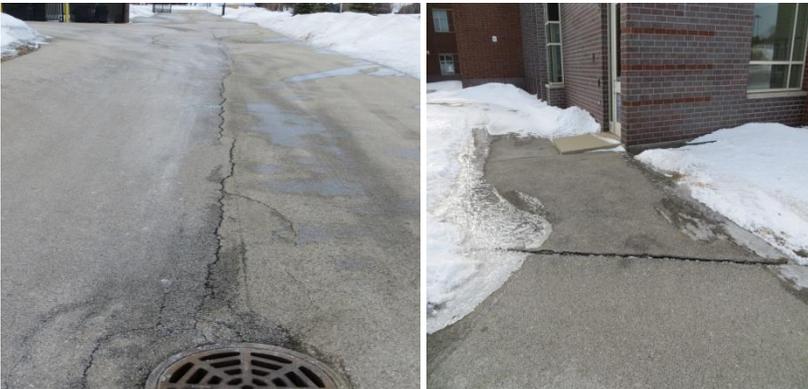
Parking Lot

Several areas are starting to show cracking.

Crack filling and seal coating will be needed within the next five years.

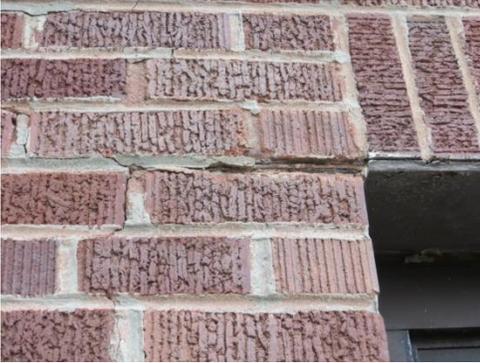
Tuck-pointing

Cracks and missing mortar joints will need to be repaired.

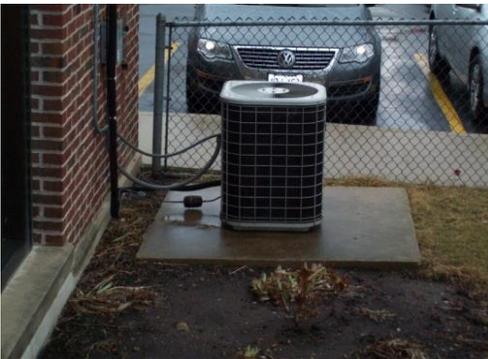
Fan Coil Condensing Unit

The entire building is cooled with fan coil units.

Several are beginning to fail and most will need to be replaced in the next 5 years.

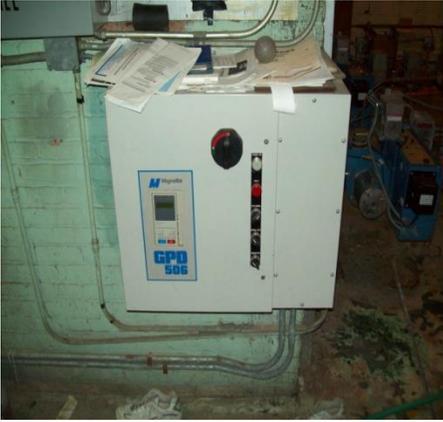
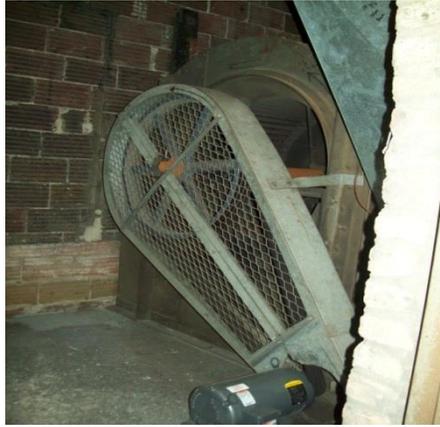
VFD and Fan for the Furnace

VFD doesn't work and fan for furnace is at least 35 years old.

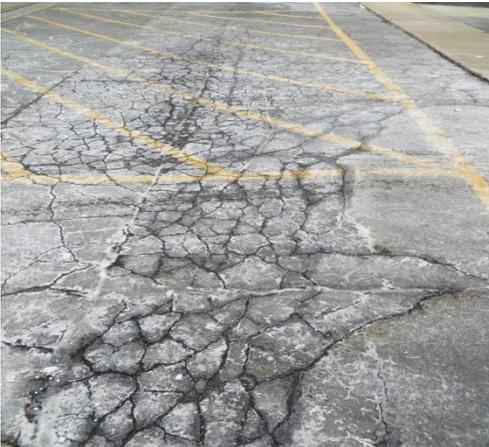
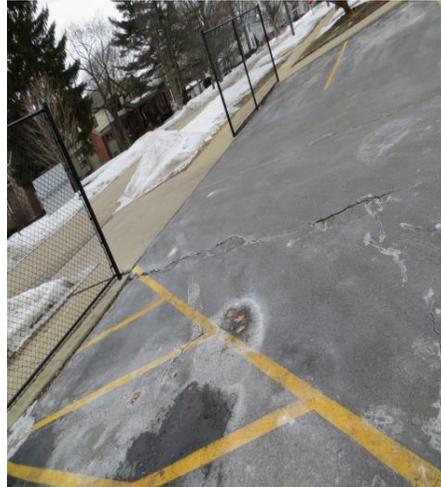
Parking lot

Several areas with extreme cracking.
Resurfacing will be needed.

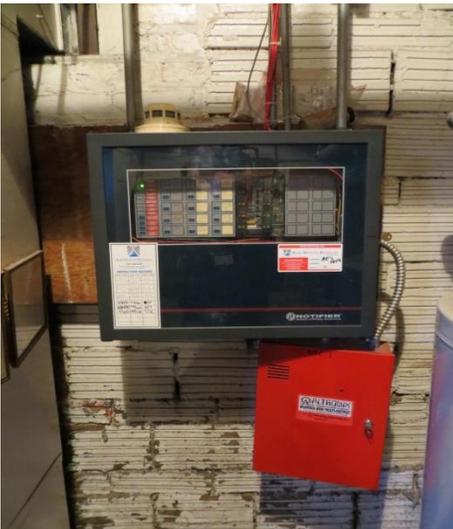
Fire Alarm System

Notifier 5000 fire alarm panel will need to be updated to meet current NFPA code requirements.

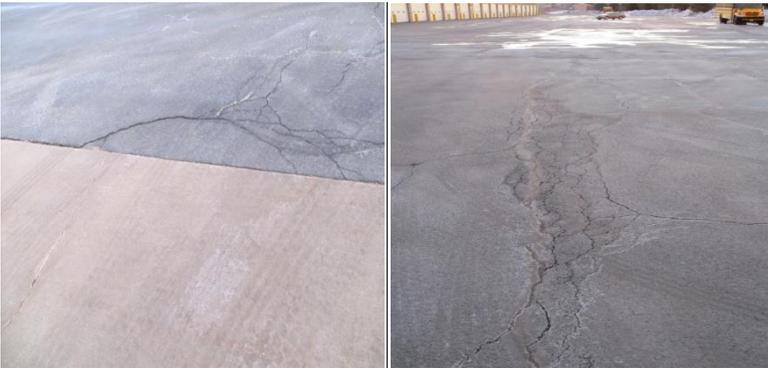
Parking Lot

Several areas starting to show cracking.

Crack filling and seal coating needed again this year due to the extreme winter.
