Geneva Community Unit School District #304
Operations and Maintenance
7 Year Capital Improvement Plan

April 10, 2023

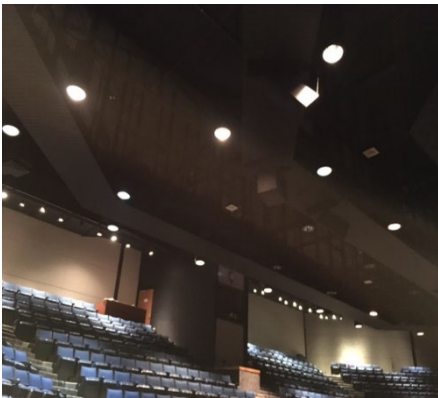
Auditorium Lighting Replacement

Parts for lighting panel are becoming obsolete and starting to fail.

Replace with energy efficient fixtures and lighting panel.

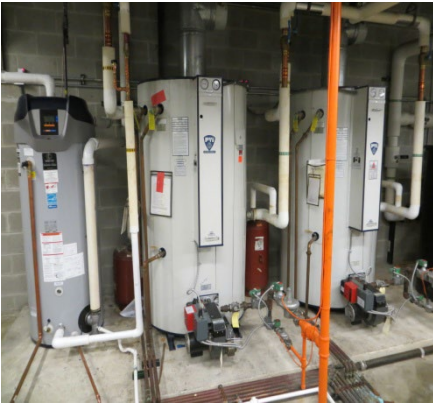
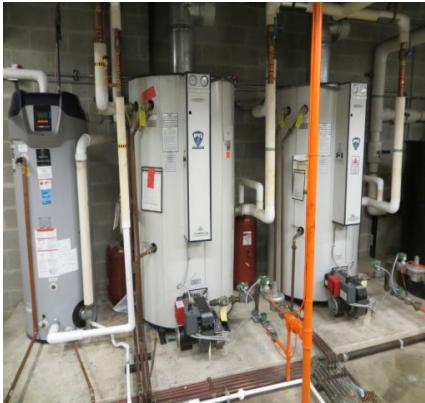
Hot Water Heaters

The two 500-gallon PVI water heaters are nearing the end of their life cycle.

Replacement will be needed within the next four years.

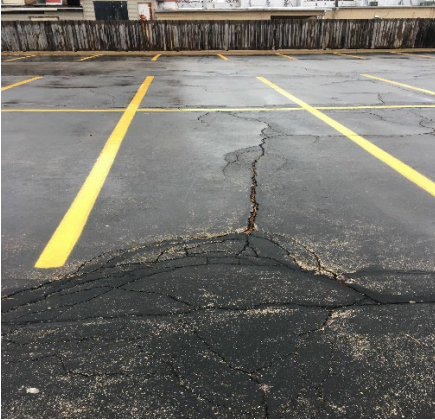
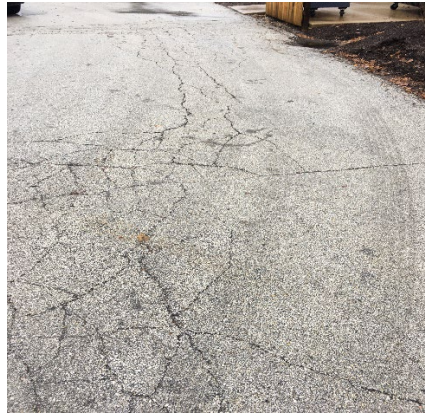
Parking lot

Several areas with extreme cracking.

Sealcoating and crack filling will be needed.

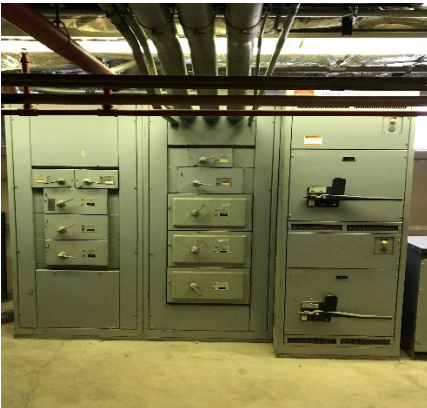
Switchboard

The 2,500-amp switchboard is 48 years old and does not operate properly.

The switchboard will need to be replaced or rebuilt.

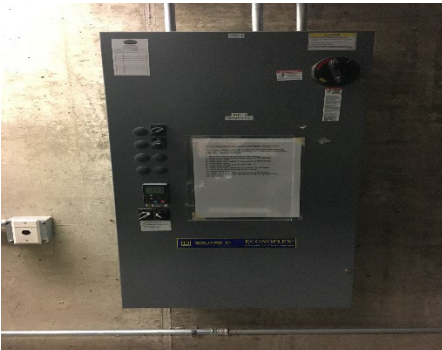
Variable Frequency Drive (VFD)

Needs replacing this year.

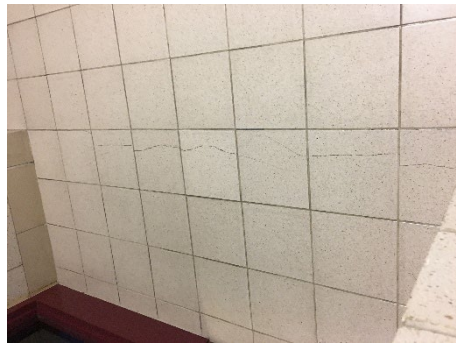
Flooring Replacement

Carpet is starting to show wear and seams are starting to pull apart.

Life cycle of carpet is 12-20 years.

Tile is lifting and cracking in several areas.

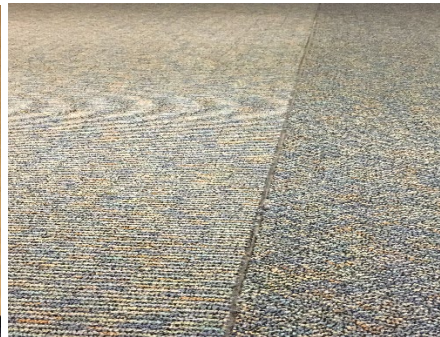
Flooring Replacement

Carpet is starting to show wear and seams are starting to pull apart.

Tile is lifting and cracking in several areas.

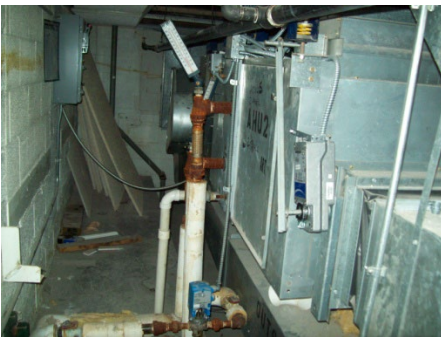
Air Handling Unit

Needs rebuilding or possible replacement.

New motor, shaft, bearings and controls needed.

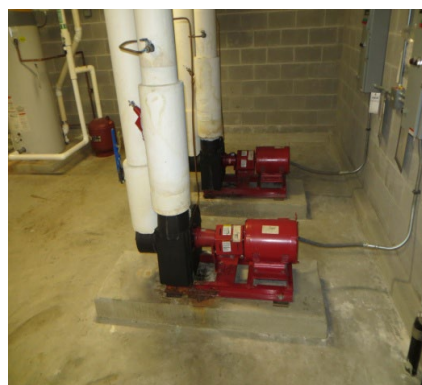
Boiler and Secondary Pumps Replacement

24 years old boilers and pumps nearing end of their estimated service life as per ASHRAE.

Need to be replaced with energy efficient design.

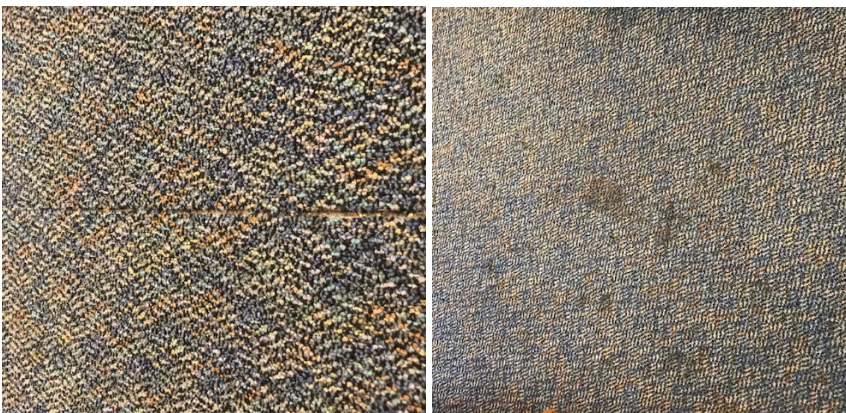
Flooring Replacement

Carpet is starting to show wear and staining that we are unable to remove.

Life cycle of carpet is 12-20 years.

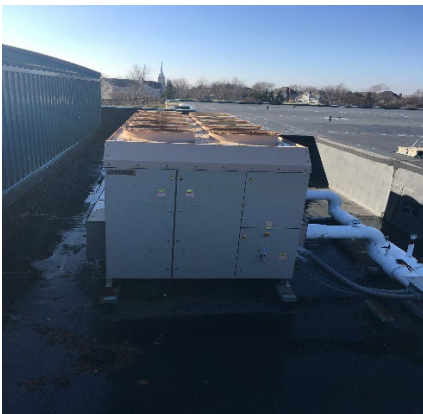
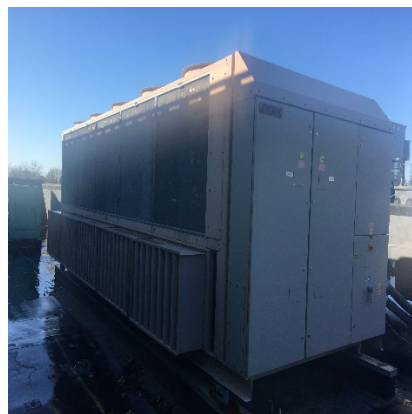
Chiller

21 years old chiller and nearing the end of its service life as per ASHRAE.

Repairs are becoming more frequent.

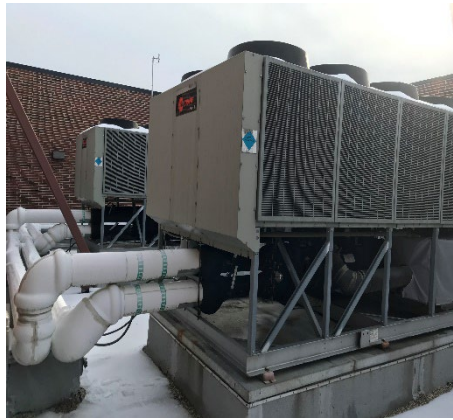
Trane Chillers

15 years old chillers are nearing the end of their service life as per ASHRAE.

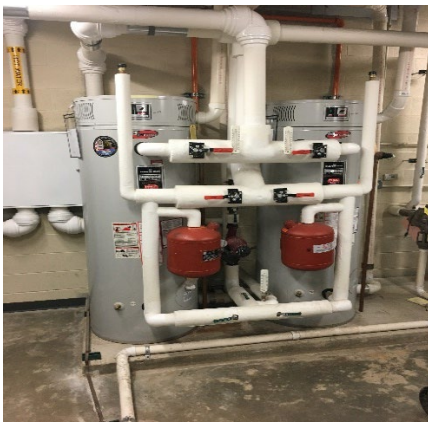
Hot Water Heaters

The two 100-gallon Bradford White water heaters are nearing the end of their life cycle.

Replacement will be needed within the next two to five years.

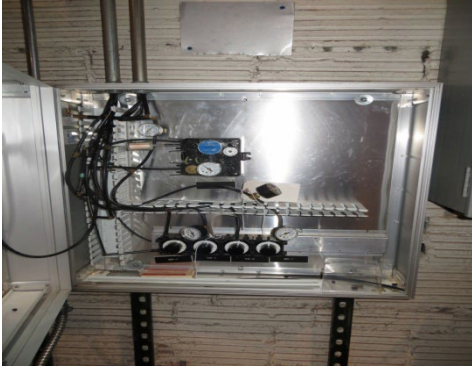
HVAC Controls

Upgrading the discontinued pneumatic controls with Direct Digital Controls.

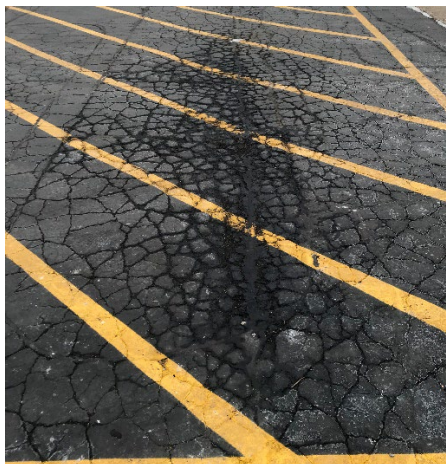
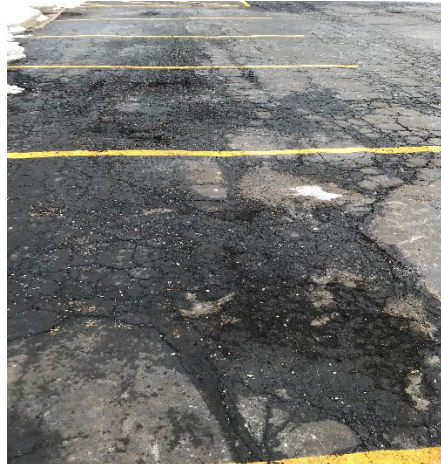
Parking Lot

Several areas with extreme cracking.

Resurfacing will be needed.
