Geneva Community Unit School District #304
Operations and Maintenance
5 and 7 Year Capital Improvement Plans

Board of Education Meeting
April 14, 2014

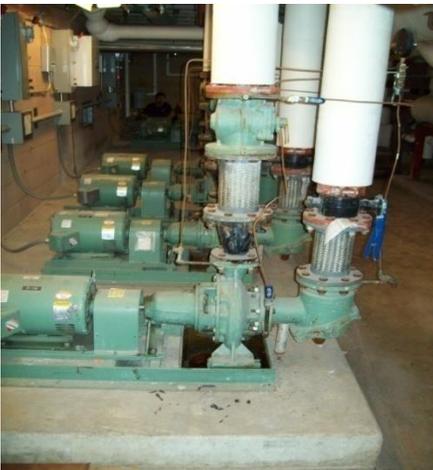
Secondary Pumps (8) – Add VFD

Variable Frequency Drives will greatly increase energy efficiency and lengthen the life of the pumps.

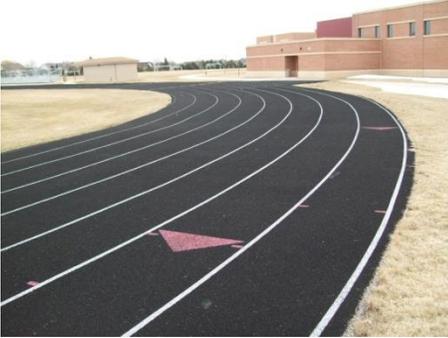
Track – installed in 2005

Track resurfacing is normally required every 8-10 years.

Excessive wear spots are apparent.

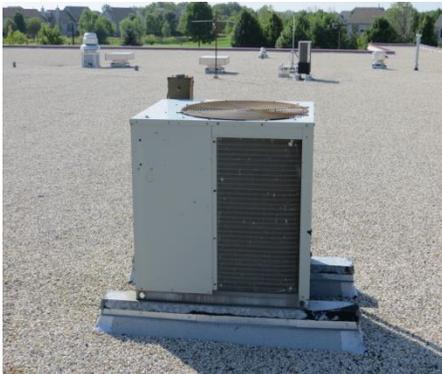
Work Room HVAC System

Original Unit installed for the building.
